Refurbishment Asbestos Survey Report

1120

Elliot Court
Herald Avenue
Coventry
CV5 6UB

12th June 2015

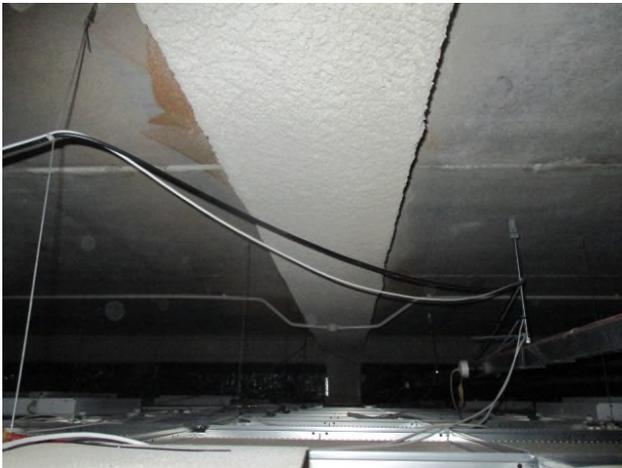
Sample 001 Sprayed coating to RSJ in open plan office area above suspended ceiling tiles. Sample returned negative for ACM's.

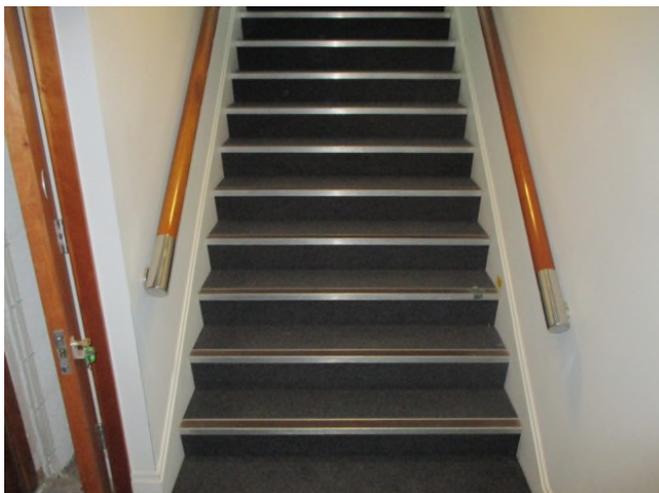
Sample 002 Stair nosing to ground floor-1st floor staircase. Sample returned negative for ACM's.

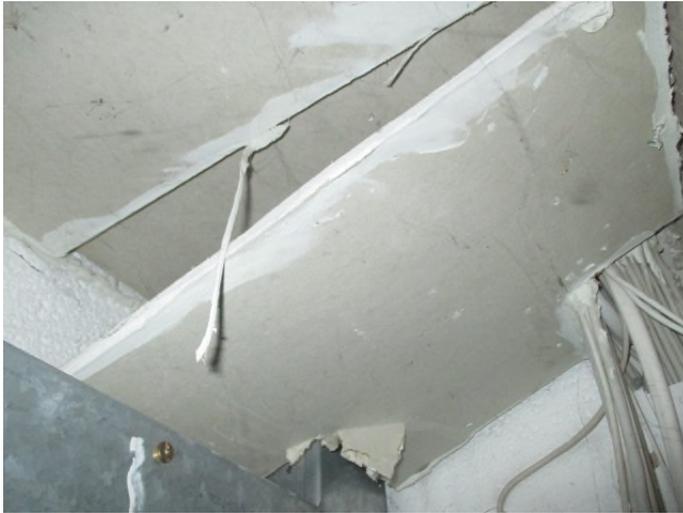
Sample 003 Boarding to ceiling of GF electrical rises. Sample returned negative for ACM's.

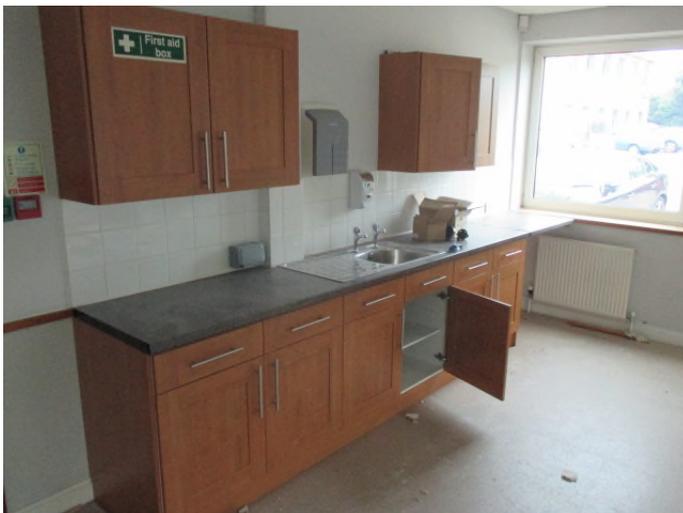
Sample 004 Vinyl flooring to ground floor kitchen area. Sample returned negative for ACM's.

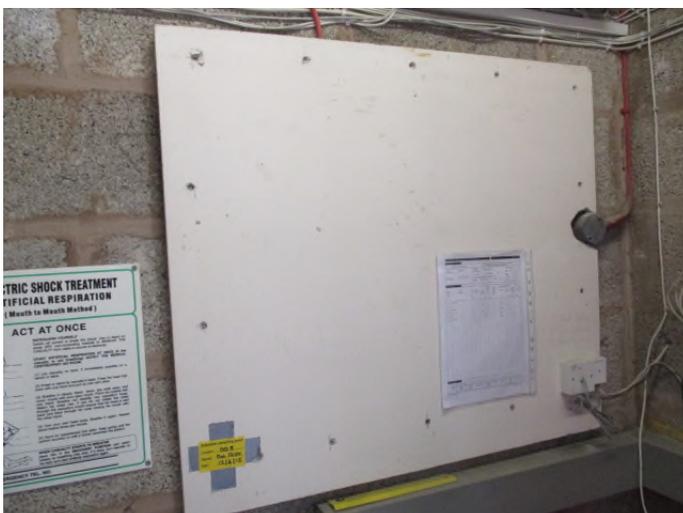
Sample 005 Boarding to electrics in lift motor room. Sample returned negative for ACM's.
